Manhole Inspection Summary

Manhole # S15I__009MH

Insp Date: **10/8/07 9:28 AM**

Location Address: **2560 FAIRMOUNT-BALTIMORE**

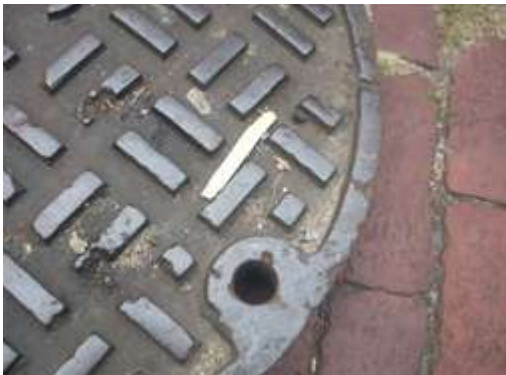
Defect 3

Condition: **Worn**

WORN COVER

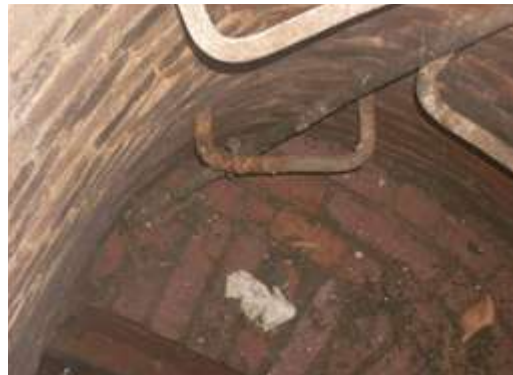
Defect 2

Count: **5** Missing: **0** ☒ **Corroded**

CORRODED STEP

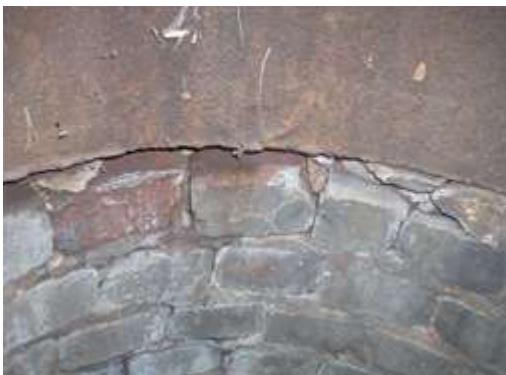
Defect 1

Condition: ☐ Sound ☐ Cracked ☐ Root Intrusion ☐ Loose Brick ☒ **Deteriorated**

DETERIORATED CORBEL

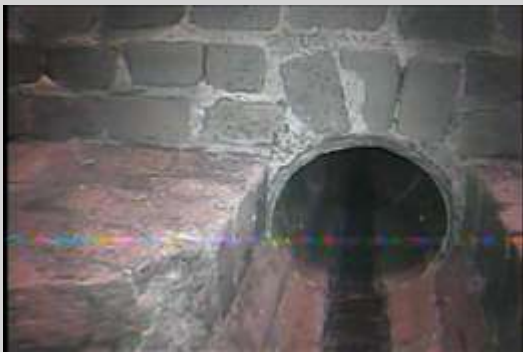
12 O'Clock Outflow

8 in. Circular Gravity Sewer
Pipe Out @ 12 O'Clock

Pipe Height: **8.4** (in.) Rod and Bar (Angled)
Pipe Material: **Clay** ☐ Pipe Lined
Invert Depth: **9.35** (ft.) Flow Characteristics: **Slow**
Deposits: ☒ None ☐ Mud ☐ Sludge ☐ Debris ☐ Grease
Silt Depth: (in.) Deposits Extent:
Infiltration: **None** Pipe Seal Cond: **Sound**

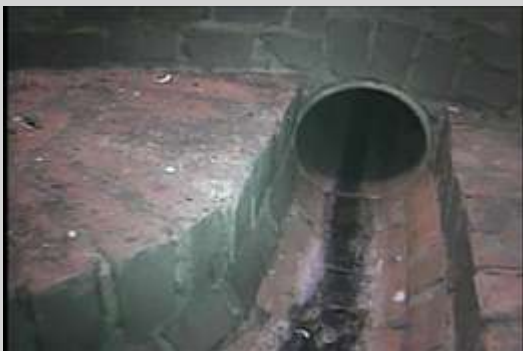
6 O'Clock Inflow

8 in. Circular Gravity Sewer
Pipe In @ 6 O'Clock

Pipe Height: **7.2** (in.) Rod and Bar (Angled)
Pipe Material: **Clay** ☐ Pipe Lined
Invert Depth: **9.31** (ft.) Flow Characteristics: **Slow**
Deposits: ☒ None ☐ Mud ☐ Sludge ☐ Debris ☐ Grease
Silt Depth: (in.) Deposits Extent:
Infiltration: **None** Pipe Seal Cond: **Sound**

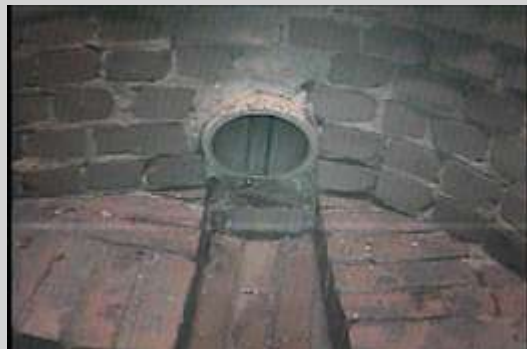
9 O'Clock Inflow

6 in. Circular Gravity Sewer
Pipe In @ 9 O'Clock

Pipe Height: **6** (in.) Rod and Bar (Angled)

Pipe Seal Cond: **Sound**
